**SAYERSBROOK LAKE DAM
WASHINGTON COUNTY, MISSOURI
MO 30112**

**PHASE 1 INSPECTION REPORT
NATIONAL DAM SAFETY PROGRAM**

HS-7848-10

Name of Dam: Sayersbrook Lake Dam
State Located: Missouri
County Located: Washington
Stream: Ashley Branch Fourche a Renault
Date of Inspection: 22 August 1978

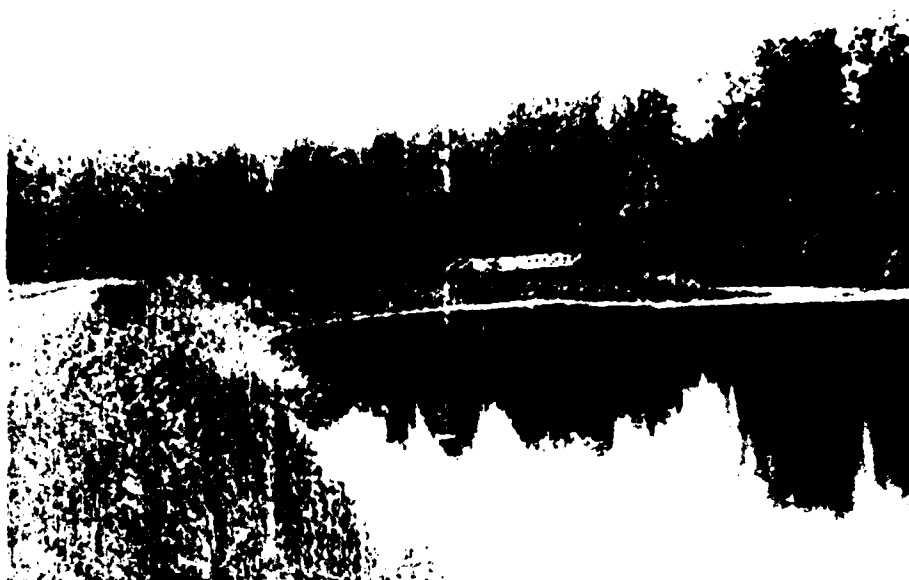
NO. 1: UPSTREAM FACE OF DAM AT RIGHT ABUTMENT

b. Dam. The visible portions of the upstream and downstream faces of the dam (see Photos 1, 2, and 3) appeared to be in sound condition although several small and medium-size trees and patches of brush exist on the downstream face. Riprap, consisting of limestone rock that varies in size from about 2-inches to about 12-inches, serves to protect the upstream slope from erosion. The riprap extends to a level approximately 3 feet above the normal waterline. The downstream slope at the junction with the left abutment is eroded, apparently by storm drainage runoff, to a maximum depth of about 3 feet. No lake seepage was noticed at the downstream toe of slope or at the junction of the embankment and abutments.

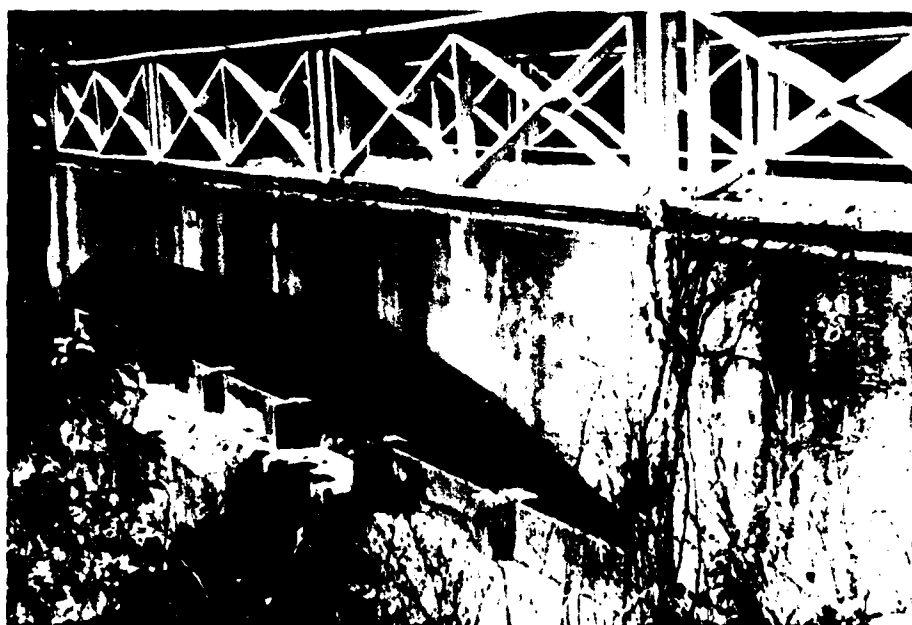
NO. 5: SPILLWAY WEIR AND BRIDGE

4. Lake water was noticed emerging in the bottom of the spillway channel at a point approximately 10 feet downstream of the concrete weir. It appears that a seepage path may have developed beneath the spillway wall. Seepage at this location could develop into a piping condition that could affect the operation of the lake.

c. Principal Spillway. The concrete weir at the principal spillway, including the 12-inch high piers for support of the wood planks and the concrete bridge crossing the spillway approach channel (see Photo 5), appeared to be in sound condition. The clear distance between the concrete weir and the underside of the bridge was measured to be approximately 3.5 feet. Water, believed to be from the lake, was emerging in the bottom of the spillway channel at a point approximately 10 feet downstream of the concrete weir. A heavy growth of small willows and brush was noticed in the exit channel (see Photo 6) between the spillway crest and the downstream channel.

(5) The possibility exists that flow emerging in the channel near the spillway weir could develop into a piping condition that would affect the operation of the lake. The Owner should investigate this condition and determine the corrective measures to be taken.
